# “A Technical Report on The Service Life of Ground Rod Electrodes”

July 7, 2003

ERICO, Inc.

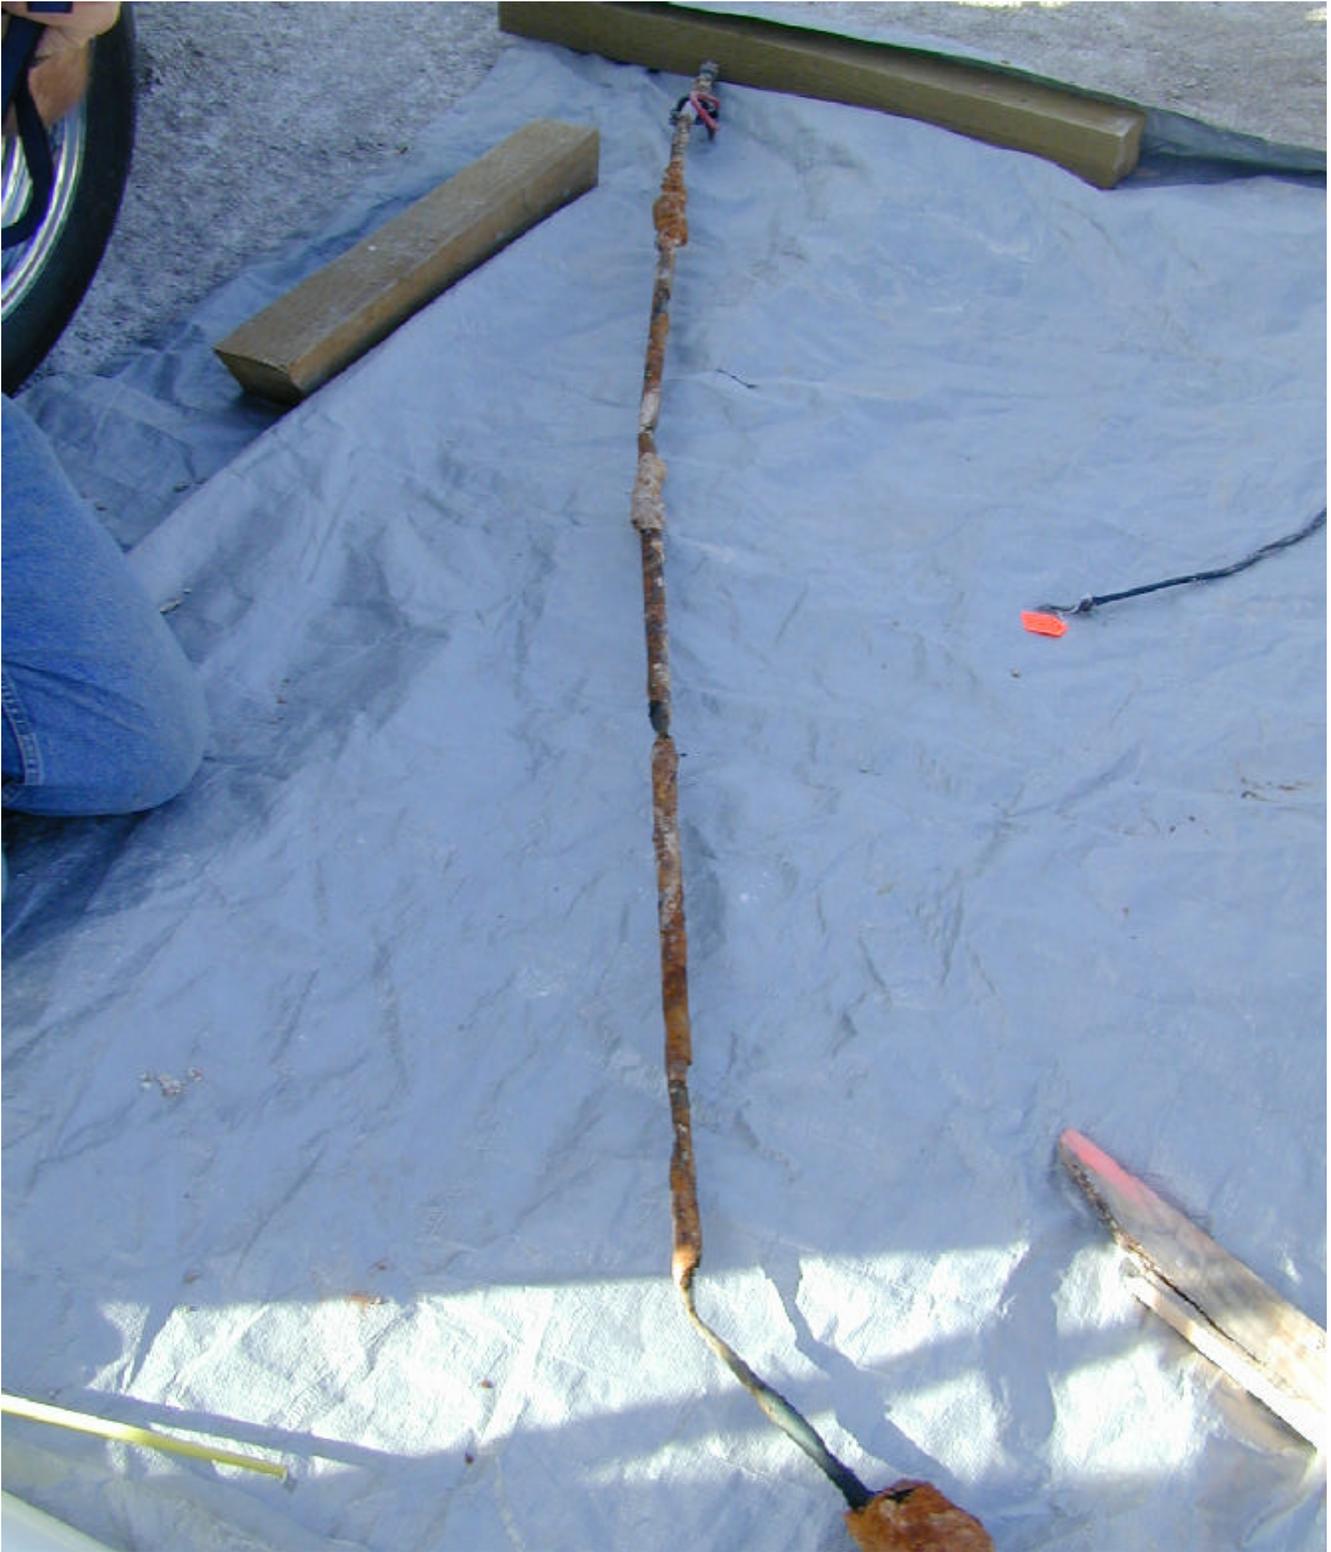
Figure 1.  $\frac{3}{4}$ " x 10' galvanized rod removed after 10 years (Pawnee Site).

The NEGRP was started in 1992 to compare the long-term performance of different types of grounding electrodes. Originally organized by the Southern Nevada Chapter of the IAEEI, the study is now governed by the Fire Protection Research Foundation. In 2003, one of the original sites (Pawnee) was excavated and the rod electrodes removed. 5/8” copperbonded and 3/4” galvanized rod samples were exhumed. The results were definitive. The 5/8” copperbonded rod was virtually free of corrosion while the 3/4” galvanized rod showed significant deterioration (see pictures on next page).

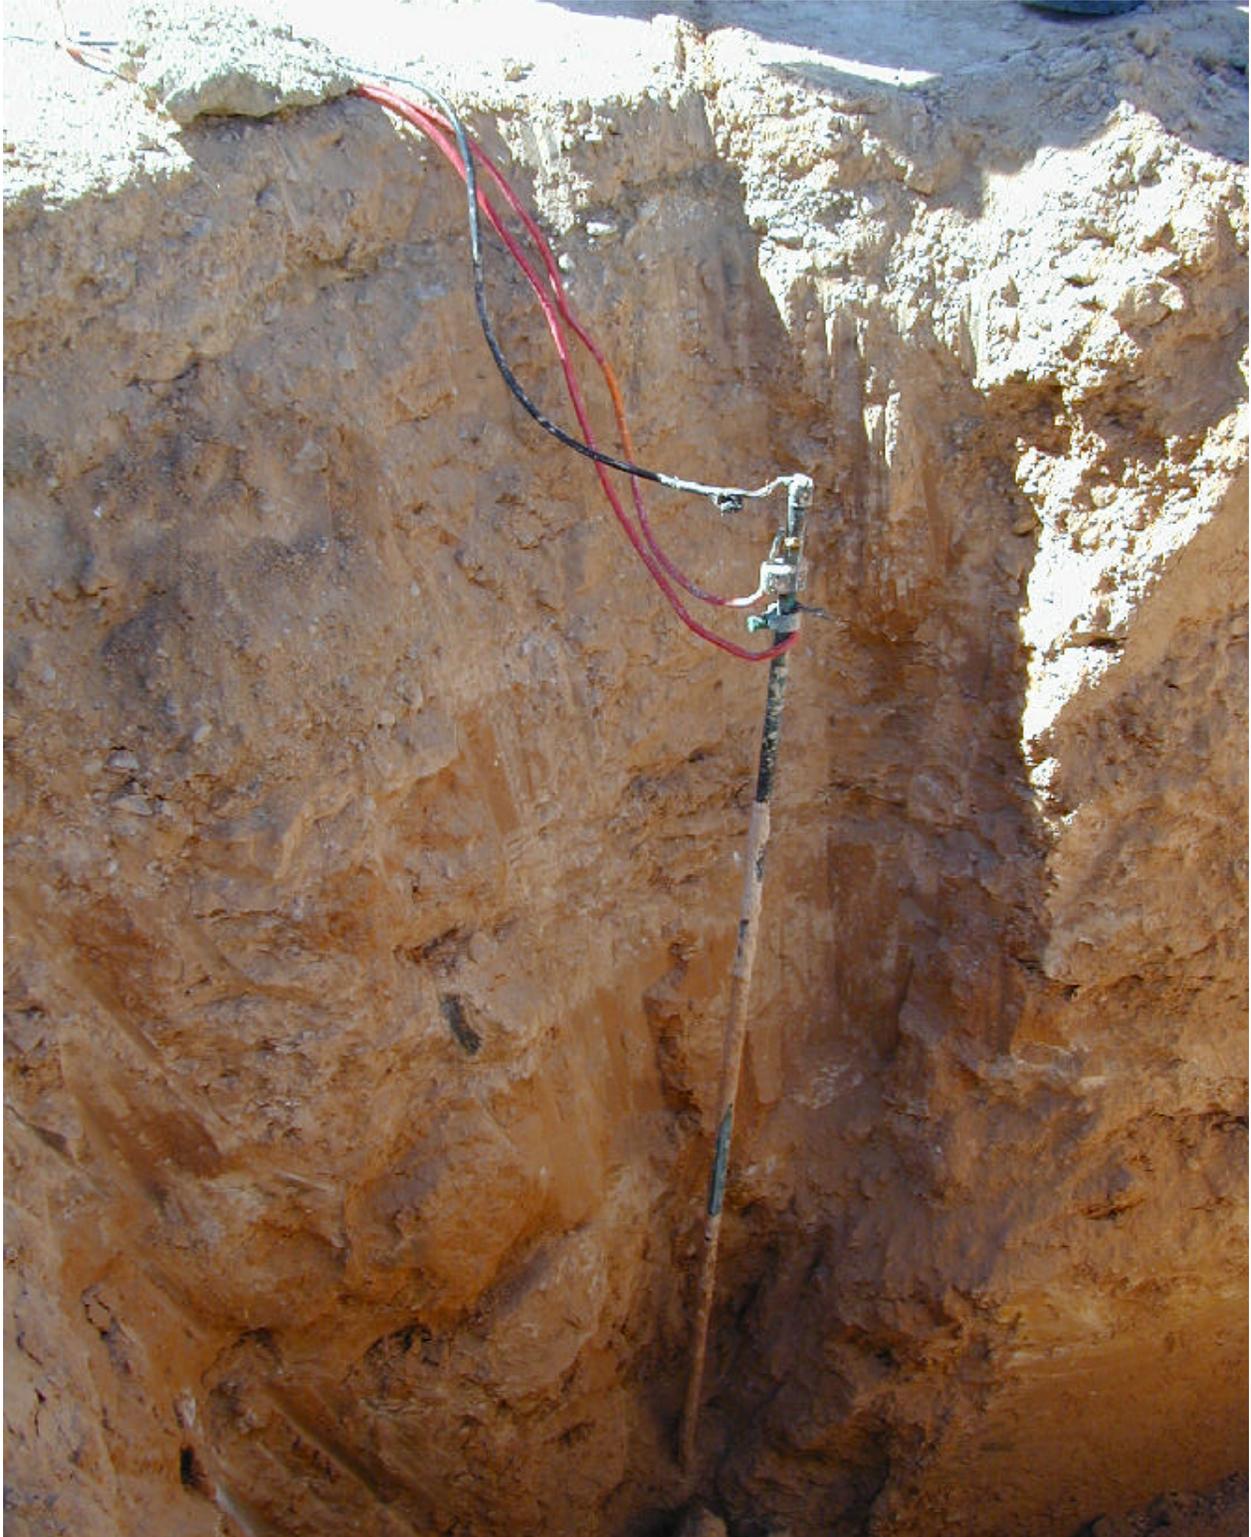
Figure 2. 5/8" x 8' copperbonded ground rod removed after 10 years (Pawnee Site).

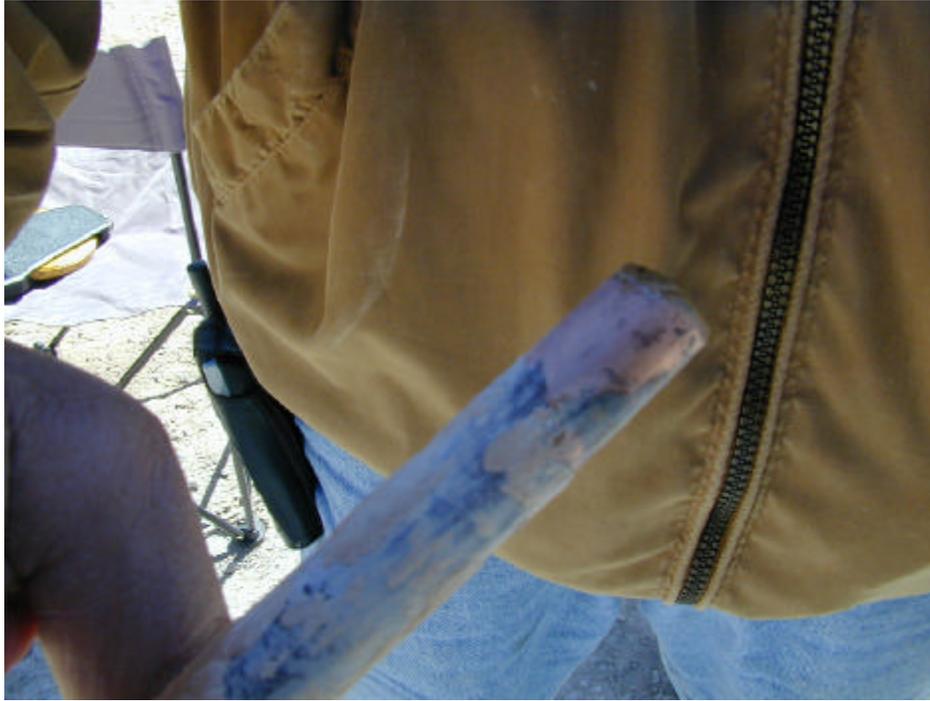
Figure 3. Close-up of 5/8" x 8' copperbonded rod after 10 years. Electrode type H.

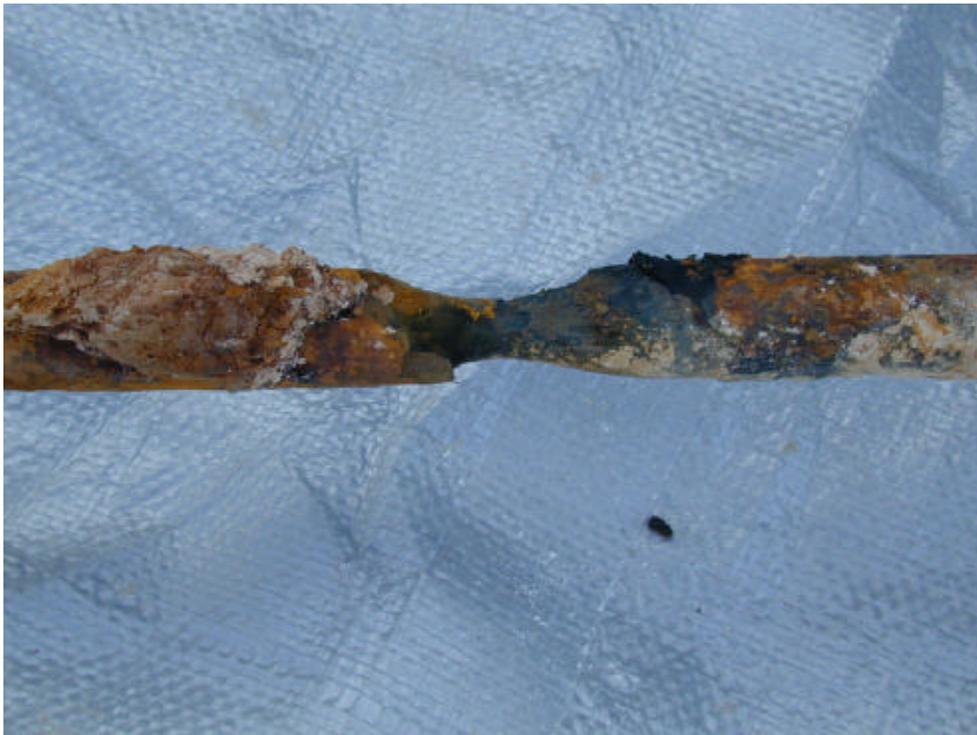
Figure 4. Close-up of 3/4" x 10' galvanized rod after 10 years. Electrode type I.
